Manhole Inspection Summary

Manhole # S33EE1024MH

Insp Date: **3/14/08 11:39 AM**

Location Address: **10 BISHOPS RD**

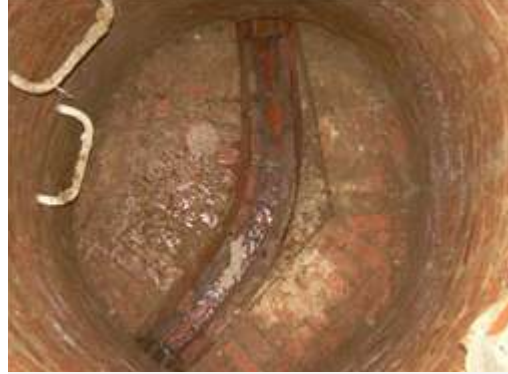
Top View

Evidence of surcharge - Bench debris.

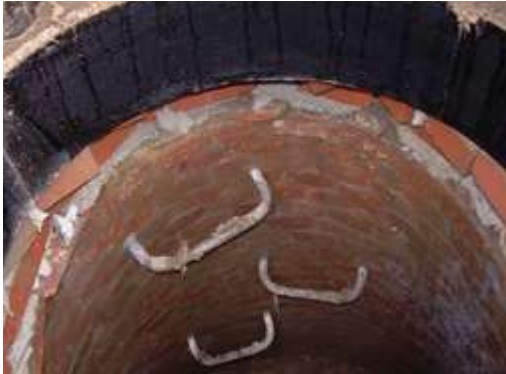
Defect

Frame offset. Adjustment deterioration, loose brick and infiltration. Barrel infiltration - other side.

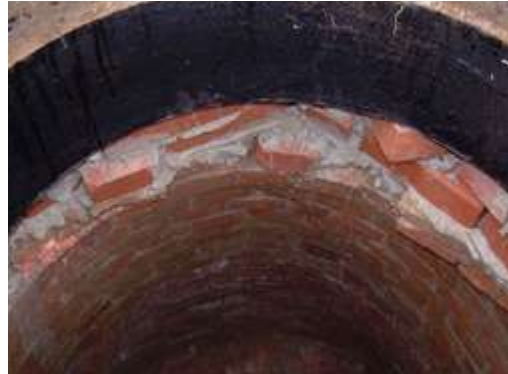
Defect

Frame offset. Adjustment deterioration, loose brick and infiltration. Barrel infiltration.

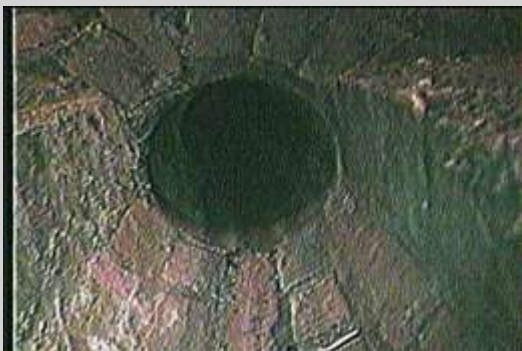
8 in. Circular Gravity Sewer Pipe In @ 7 O'Clock

Barrel deterioration and infiltration.

Infiltration: **Evidence** Pipe Seal Cond: **Cracked**
